6th Fatigue Design conference, Fatigue Design 2015

## Fractography, a powerful tool for identifying and understanding fatigue in composite materials

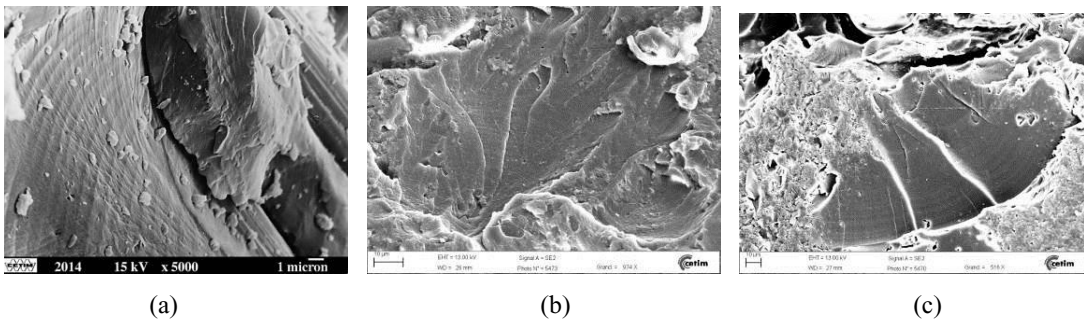
Figure 8 Fatigue matrix striation (a) carbon/epoxy industrial part; (b) and (c) glass/epoxy aeronautical blade

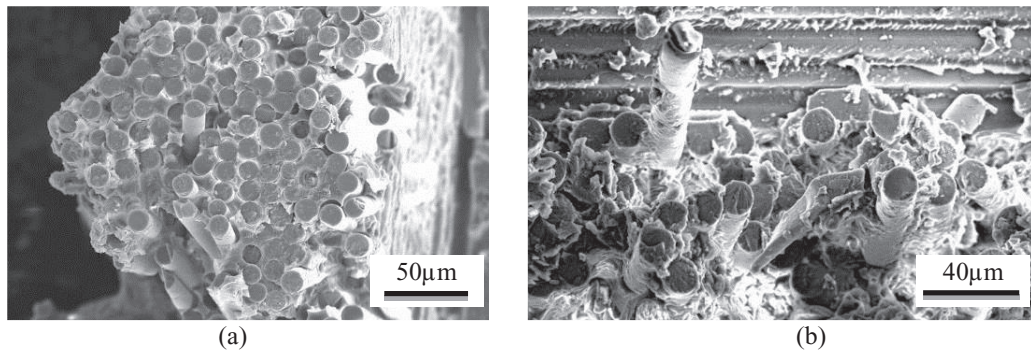
Figure 10 Tensile failure of an aeronautical glass/epoxy composite component: (a): fatigue initiation area one single plane of fracture for many glass fibers and smooth individual fracture surfaces; (b): typical monotonic tensile features on a glass fibre fracture surface.

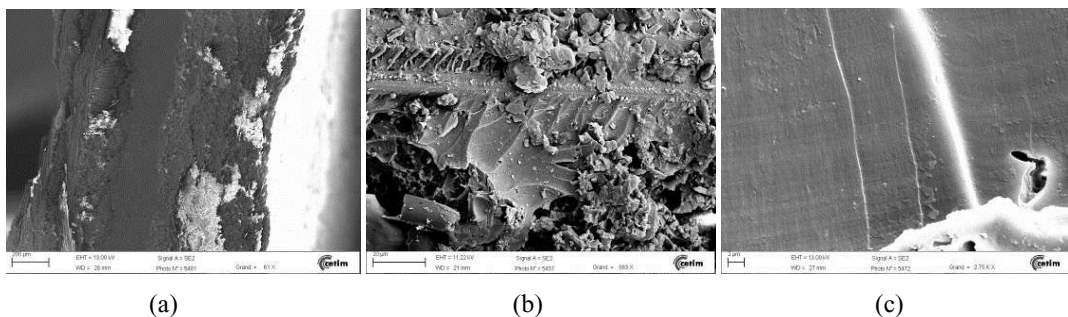
The study described here presents failure of a glass/epoxy component, fabricated from unidirectional glass fibre and fabric reinforcement under tensile loading. There were no environmental stresses applied to the part. The location of the initiation site was easily found where the opening of the crack was more pronounced. Scanning electron microscopy of the initiation area was undertaken, with a very smooth surface observed at this site, as shown in Figure 13. Such smoothness is often the sign of wearing due to friction between broken surfaces under cycling loading. Observation at higher magnification showed a high degree of fibre and matrix debris (see Figure 13). Finally fatigue striations were observed in the matrix at several locations (see Figure 13). Examination of this failed part showed that the loading at the origin of the failure was cyclic.

Figure 13 (a): smooth surface due to wear; (b): matrix and fibre debris; (c): striation in the matrix

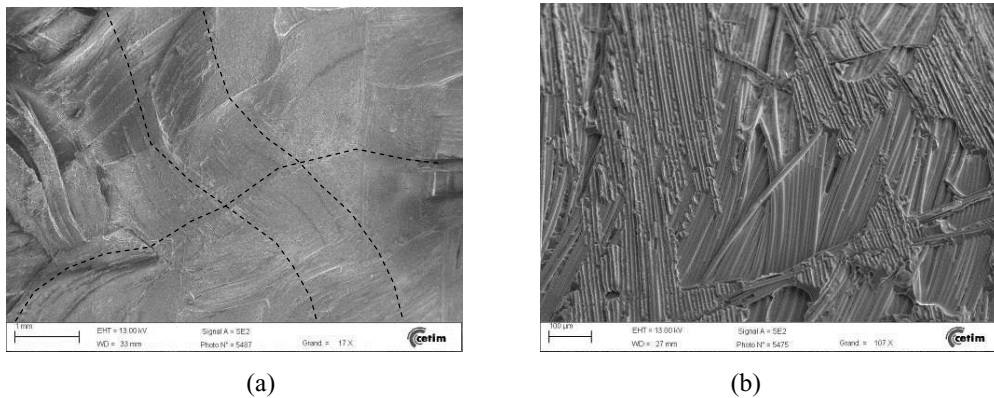
At sites where fatigue morphology was found, several manufacturing defects were identified. This example is a good illustration of what is often observed in organic composite materials: one manufacturing defect leads to secondary defects around it. In this instance, as shown on Figure 14(a), the main defect is waviness of glass fibre fabric. Over this entire waviness region, there was matrix rich zones and porosity Figure 14(b).

Figure 14 (a): waviness of the glass fibre fabric; (b) wild porosities in the waviness area
